REPORT NO: MT-07/234-B

## LOAD TESTING OF POWER CABLE HOOK-PULLEY DEVICE

## **TEST SYNOPSIS:**

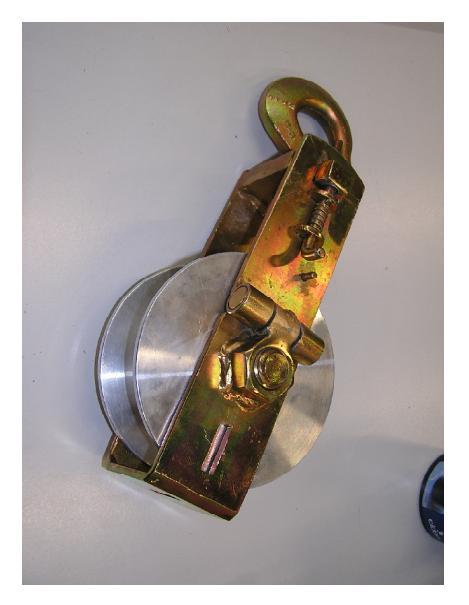
FIG.1. Pulley Test Item

A hook-pulley device used to haul electrical cable was tested by Melbourne Testing Services (MTS) for load capacity. The test item, as shown in Figure 1, was manufactured from metallic materials and consisted of an aluminium pulley, steel frame and swivel hook.

- HOOK: Class 8 M-LI, A-WLL-2t.
- FRAME: No identification details were noted.
- PULLEY: No identification details were noted.

The hook-pulley supported the test load without failure. There was no visible evidence of cracking or plastic deformation in the pulley or hook components of the test item. Permanent deformation was observed in the hinge mechanism of the frame.

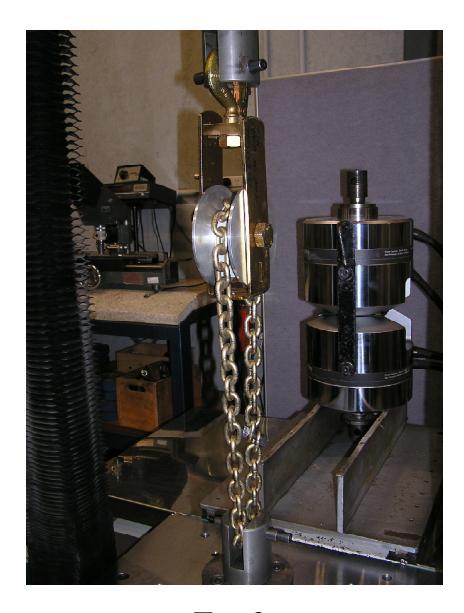
FIG.2. Load Test Set-up

Testing was conducted by coupling the pulley device into a tensile testing machine (See Fig.2). Tensile load was then applied until the nominated test load of 60kN was achieved. At this point the load was maintained for 30 seconds before terminating the test.
